PENNSYLVANIA
VIRGIN RUN DAM

NDS I.D. No. PA - 00196
PENNDER I.D. No. 26 - 85

PHASE I INSPECTION REPORT
NATIONAL DAM INSPECTION PROGRAM

AUGUST 1979 1 7

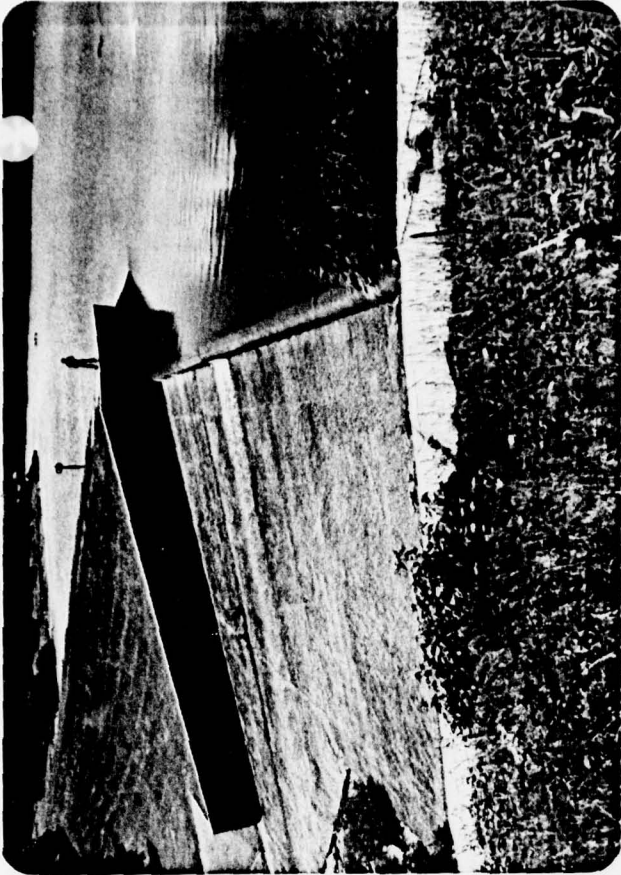
PHOTOGRAPH 2 View of spillway located adjacent the left abutment.

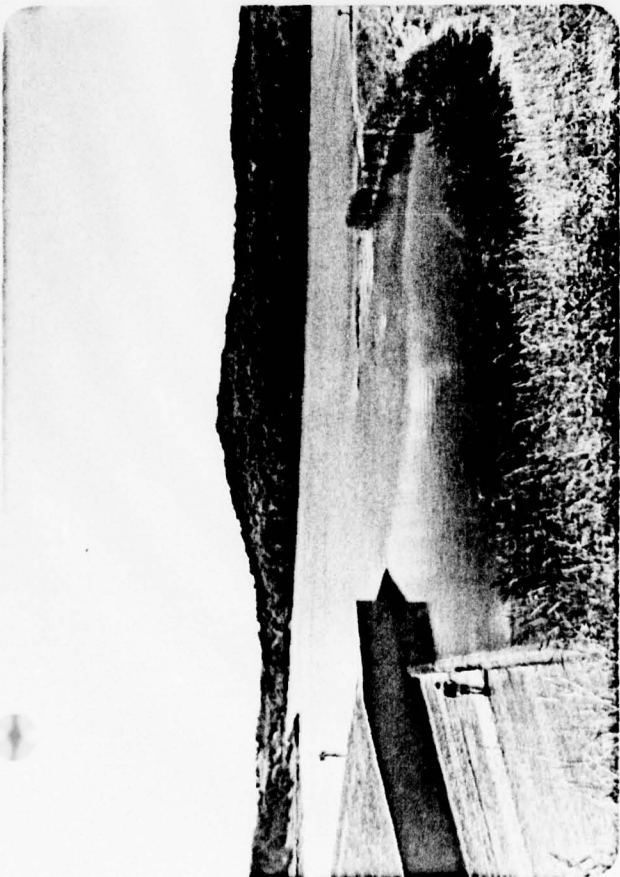
d. Reservoir Area. The area surrounding the reservoir is characterized by gentle to moderate slopes that are generally heavily forested along the southern and eastern shores of the lake (see Photograph 1), but only partially wooded to the west (see Photograph 4). Virgin Run Lake is a

PHOTOGRAPH 1 View, looking south, at Virgin Run Lake and watershed.

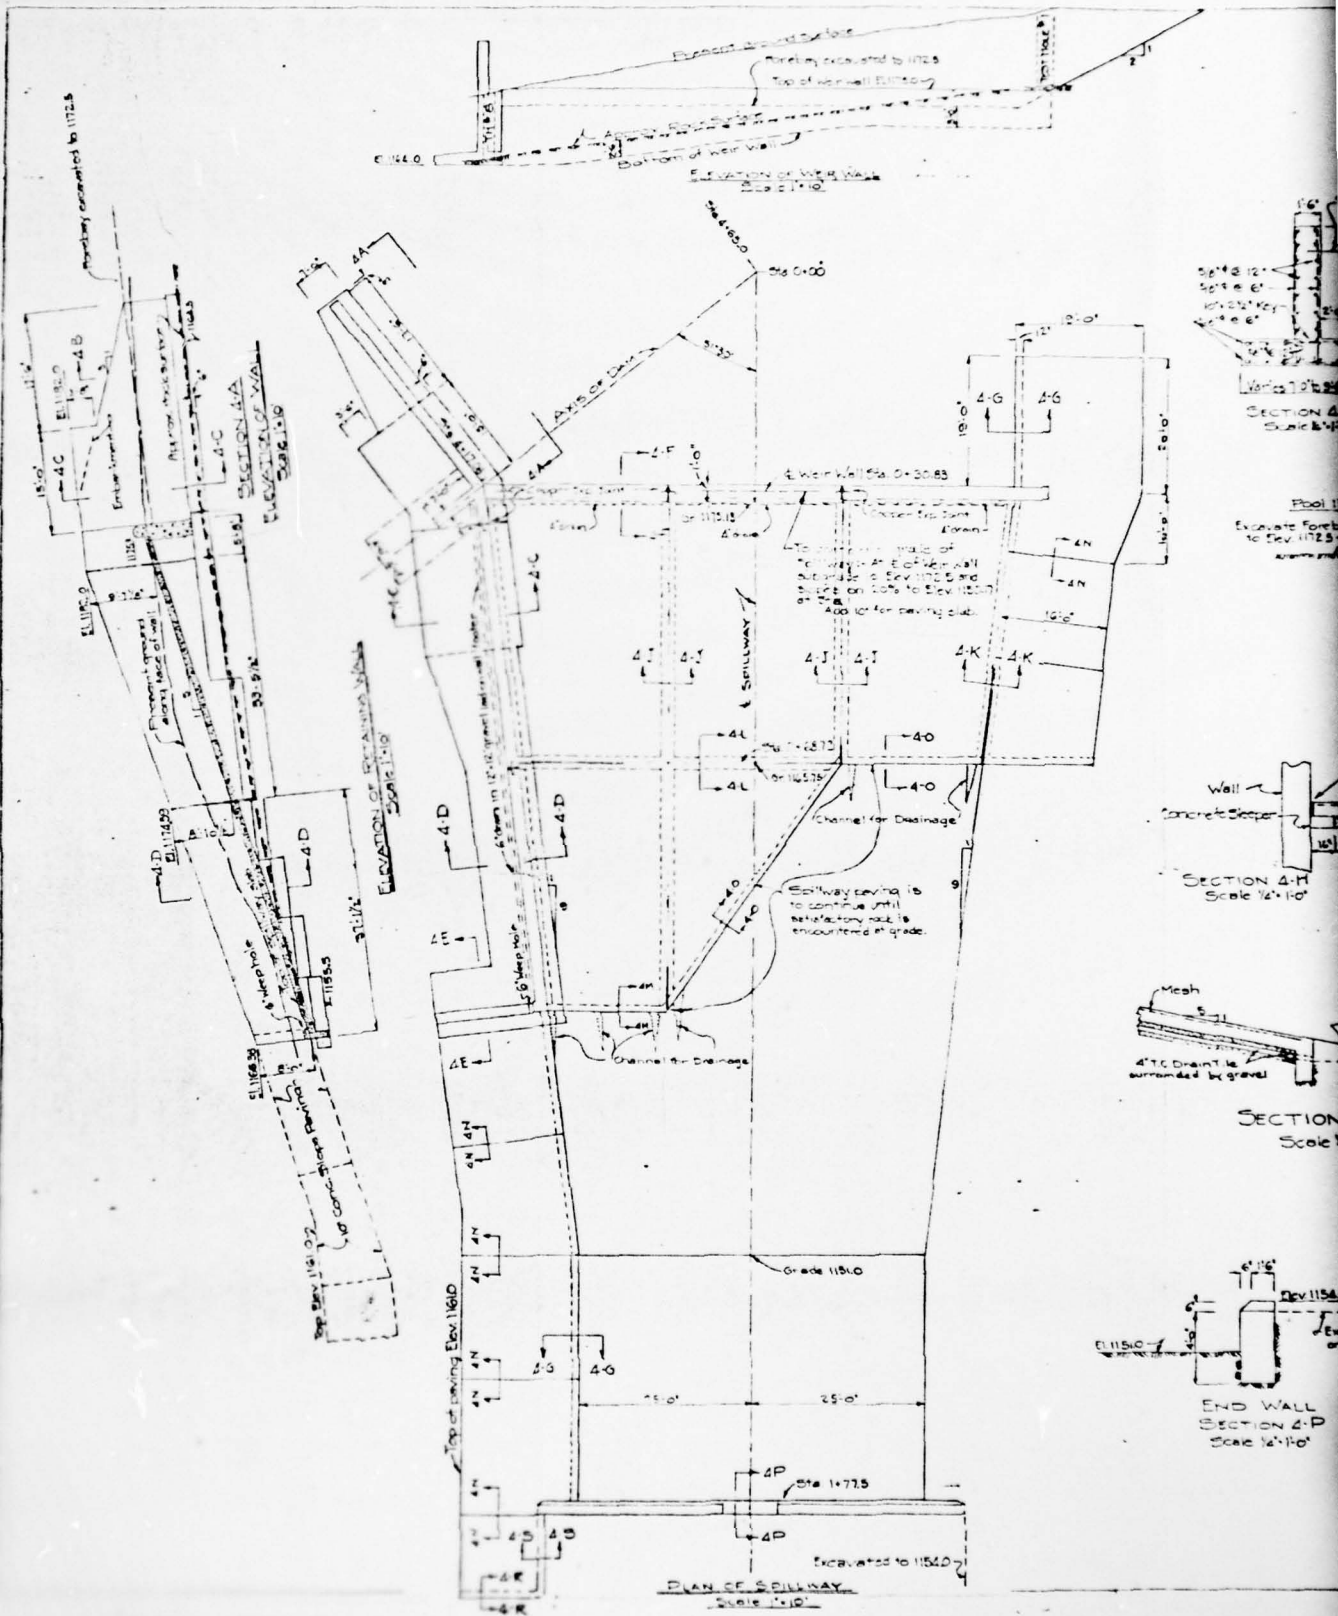
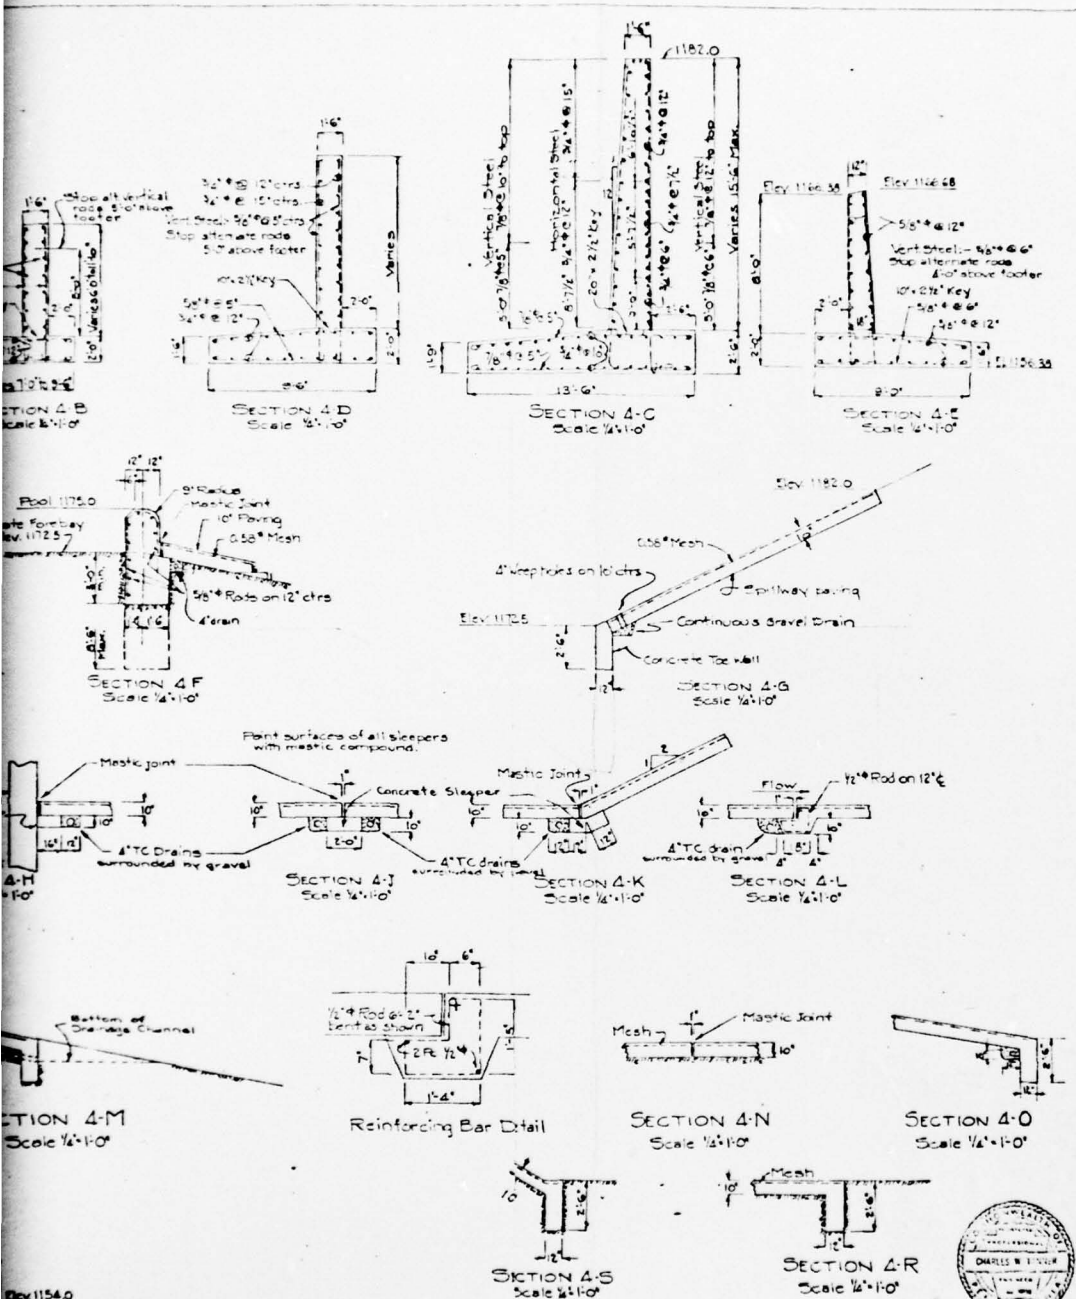
FIGURE 5

a) Spillway. The spillway at Virgin Run Dam is a trapezoidal-shaped, concrete chute channel, with discharges controlled by a reinforced concrete overflow weir structure, located at the left abutment (see Photograph 2). The spillway channel is partially unlined as it was cut into durable rock (see Figure 5 and Photograph 3). The original design was altered somewhat during construction to include the addition of a concrete apron as shown on Figure 6.
